All About the Nails

**Gregory A. Kopp
and Murray J.
Morrison**

Boundary Layer Wind
Tunnel Laboratory,
University of Western
Ontario (London, Ont.)

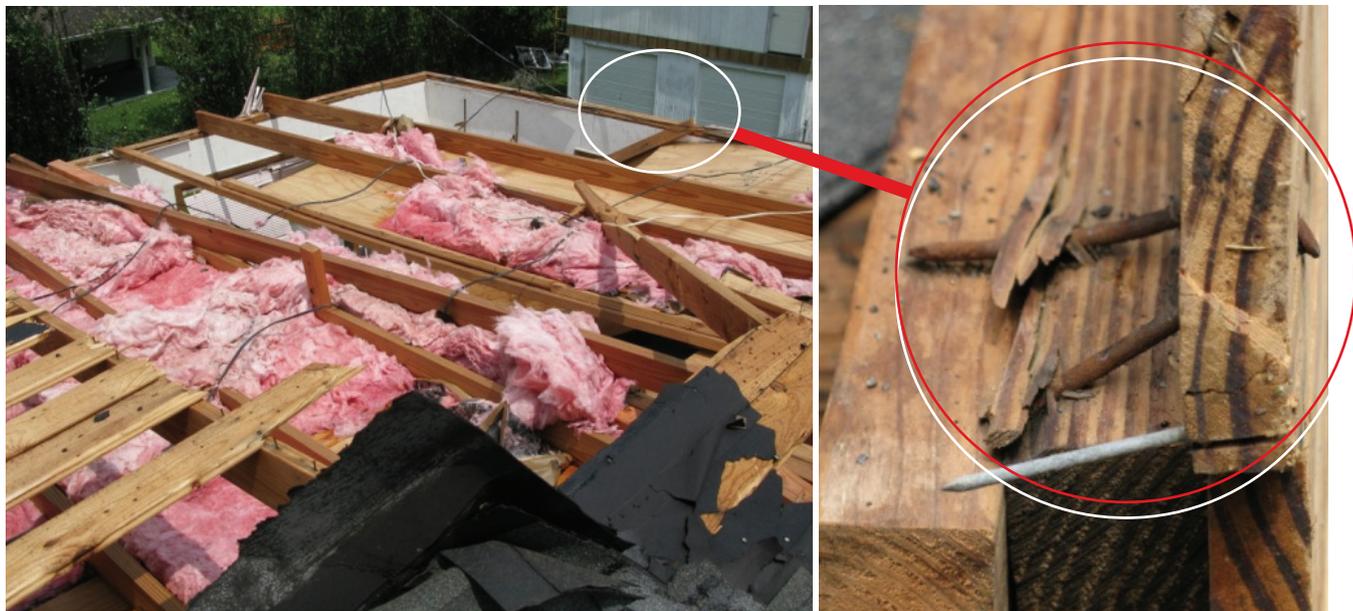
After stopping and restarting the actuators, each time ramping up the pressure, it was discovered that the nails in the roof began to pull out a bit at a time. (See Figure 2 on Page 62.) There are several high-speed wind gusts over the duration of 15 minutes; these cause significantly elevated pressures. The largest uplift forces are of short duration, typically less than a few seconds and often less than a second. In fact, in these particular tests, there is a moment in which the load tripled in value in about half a second. For Category 1 wind speeds, this meant nails pulling out about 1 mm. For Category 3 wind speeds, this

meant nail displacements of about 20 mm. However, as the gust passed, the weight of the roof would push the trusses back down, taking the nails with them. By the time the Category 3 test was completed, there was total failure of the toenails; they had no capacity left to resist the wind uplift. At this point, the

Figure 2: Photograph of roof damage to a house in Houma, Louisiana caused by Hurricane Gustav. The roof joists at the corner were not connected to the walls. The photograph on the right shows a close-up of the corner of the roof section that flew off of the house. There were toenails in the joist, they just had not been connected to the walls.
