Ontario's second Safer Living home is launched—Canada's third

Hurricane Gustav—Observations from the eye of the storm 3

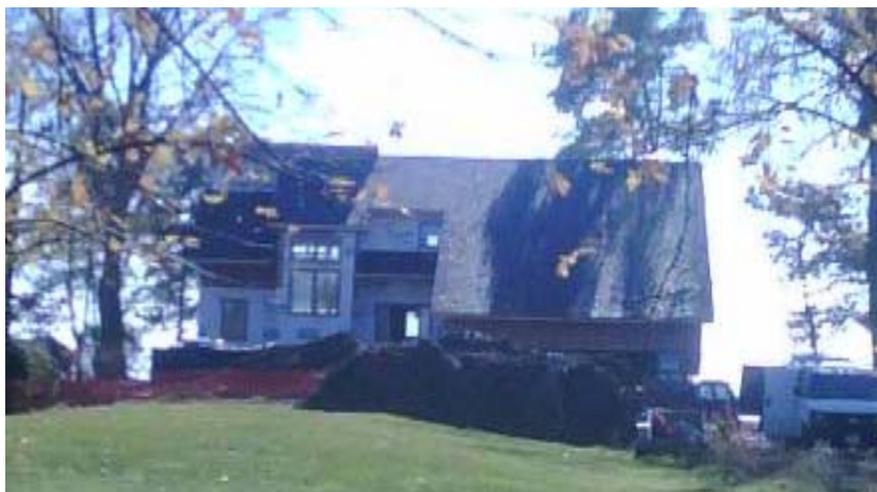
The roof of the home is tied down with hurricane straps.

- steel hurricane clips and strapping to secure the trusses to the framing, and braced gable ends to withstand high winds;
- reinforced rebar in the foundation;
- wider foundation footings;
- triple-glazed windows and doors;
- laminate shingles installed with additional nails;
- ice and water shield over the entire roof;
- spray foam insulation; and
- 5/8-inch fire rated drywall.

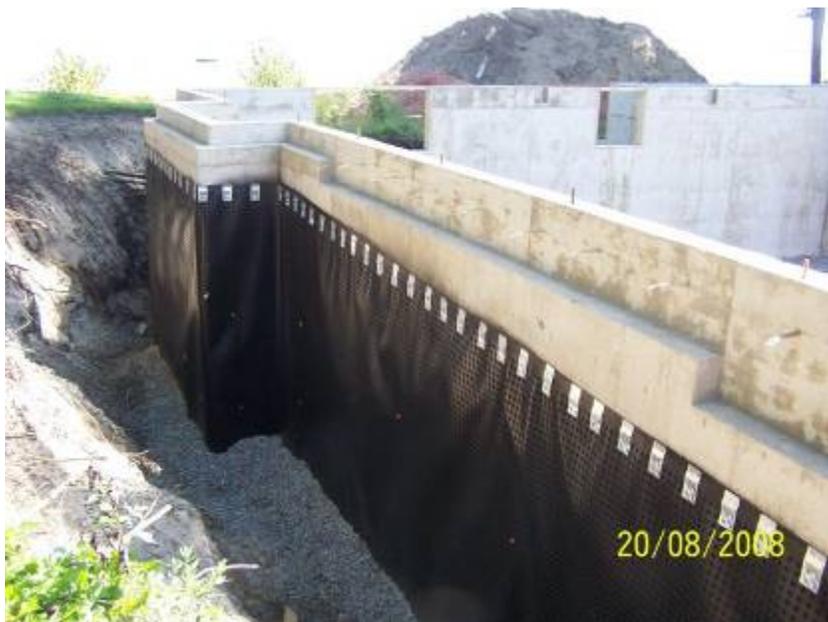
The Fort Erie home was built on a strong foundation, with reinforced steel rebar.

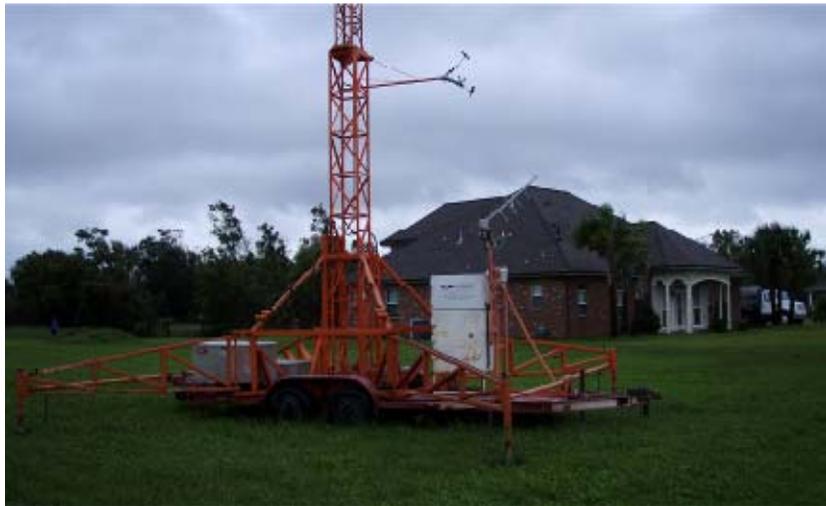
Photograph of tower belonging to the Florida Coastal Monitoring Program of the University of Florida, deployed in a suburban neighbourhood in Houma, Louisiana during Hurricane Gustav. This tower measured peak gust wind speeds of less than 80 mph. The house in the background was undamaged except for loss of about 2% of shingles. Nearby houses lost up to 50% of the shingles.

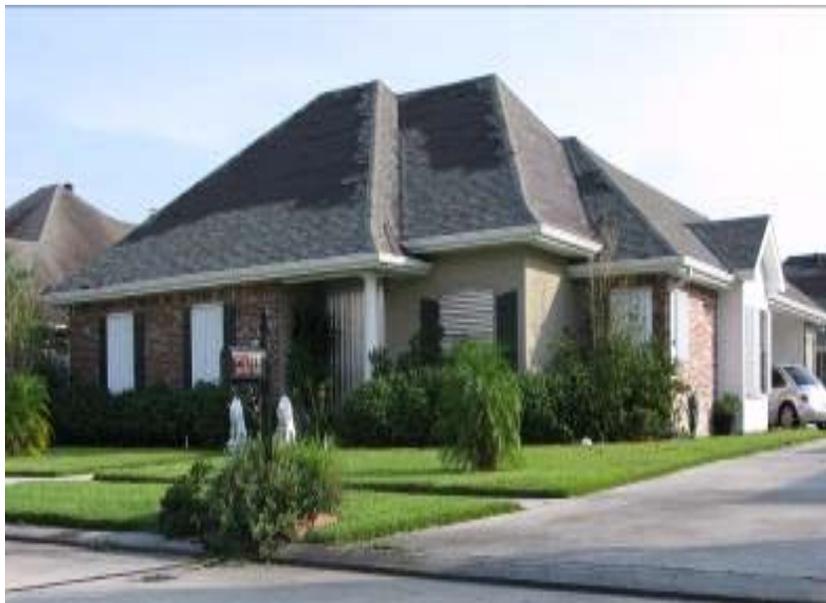
Photograph of a recently-constructed house in Houma, Louisiana the morning after Hurricane Gustav made landfall. The general lack of debris indicates a relatively minor wind event, although one cannot see all of the shingles in the

backyard that flew off from the front of the house. Note that this area had been evacuated and no one had yet returned to clean up; we were the only people there except for Emergency Response Personnel.

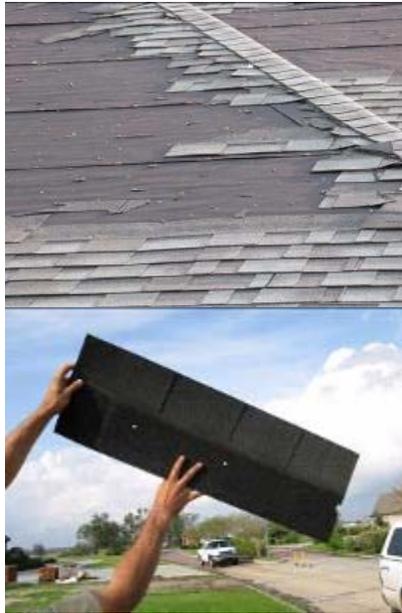
Close-up photographs showing typical shingle failures with the nails still in the roof (top) and one of the shingles that came off with two nail holes visible (bottom).

As a result of these observations during the storm, the team decided to conduct a damage survey on the following day of more than 1000 houses in Houma, in randomly chosen streets, but covering every quadrant of the city. It was apparent that shingle failure was the only real issue in Houma, aside from the downed power lines and trees, so our damage survey focused on this issue alone. It seems that the problems were primarily with new construction with relatively high roof slopes and few trees around. Preliminary analysis suggests these failures may have been due to insufficient connection between the adhesive on the underside of the shingle, with the roof. This led to shingle tabs flipping over and pulling the shingles over the nail heads. The close-up photos show this in detail.

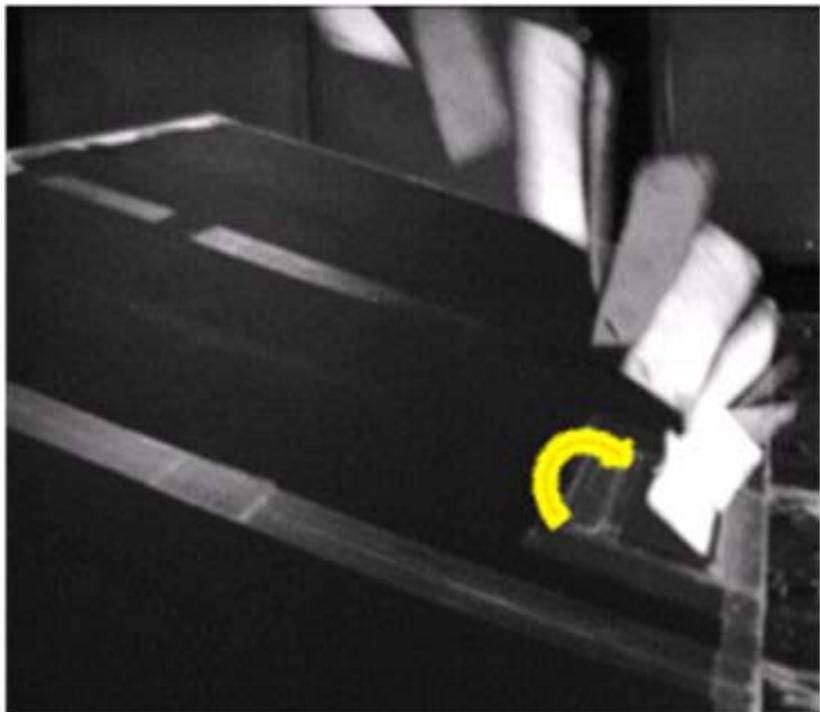
Close-up stroboscopic image showing a single realization of shingle flight from the roof of a house in a scale model wind tunnel study. In this image, the shingle fails in the lower right, gets caught up in high speed flow at the roof edge, and accelerates upwards, eventually moving downstream with a speed higher than the gust speed upstream of the house that actually caused the failure.

surprising facts, perhaps the most important pertaining to the flight speeds of the shingles. Typically, shingles can fly at speeds in the range of 50% to 120% of the undisturbed, upstream gust wind speed. This is a large range and is due to the nature of the turbulent wind gusts. While the shingles do not fly faster than the wind (actually they can, but there is not space to explain that interesting fact here), wind is actually accelerated above the roof of the

house. Since the shingles are so light, they also accelerate quickly, leading to these high flight speeds. What this means, practically, is that they carry a lot of energy and the potential to break windows. They can also travel very far. Just as important for answering the question above, is to determine the flight speeds which break windows, and such research is currently being conducted at the University of Florida using full-scale impact tests. We have just begun to link the data from these two types of experiments.

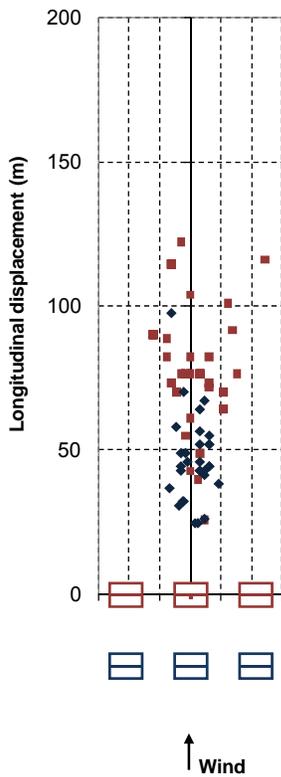
Typical flight distances observed in wind tunnel experiments. Note the great variability and that typical trajectories are further than the distance between houses.
