Shingle Damage: In the Eye of the Storm

New research is trying to get a true measure of wind speeds and shingle damage in order to help model for hurricane damages.

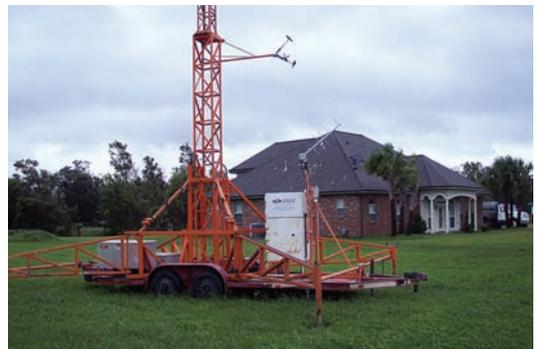
Photograph of tower belonging to the Florida Coastal Monitoring Program of the University of Florida, deployed in a suburban neighbourhood in Houma, Louisiana during Hurricane Gustav. This tower measured peak gust wind speeds of less than 80 mph. The house in the background was undam-

aged except for loss of about 2% of shingles. Nearby houses lost up to 50% of the shingles.

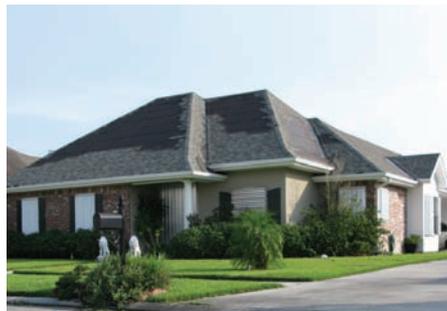
Photograph of a recently-constructed house in Houma, Louisiana the morning after Hurricane Gustav made landfall. The general lack of debris indicates a relatively minor wind event, although one cannot see all of the shingles in the backyard that flew off from the front of the house. Note that this area had been evacuated and no one had yet returned to clean-up; we were the only people here except for Emergency Response Personnel.

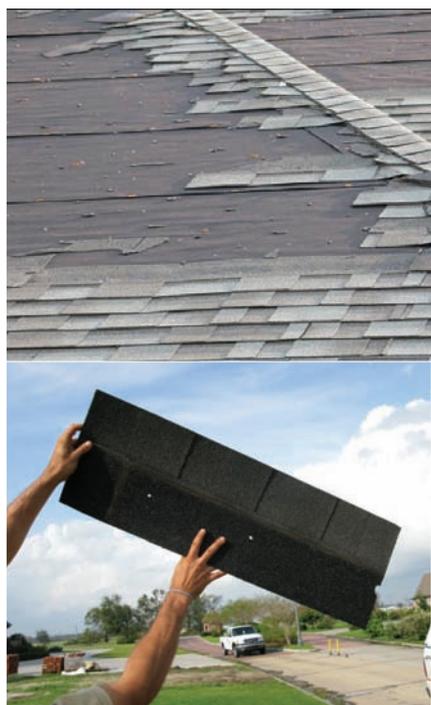
only real issue in Houma, aside from the downed power lines and trees, so our damage survey focussed on this issue alone. It seems that the problems were primarily with new construction with relatively high roof slopes and few trees around. Preliminary analysis suggests these failures may have been due to insufficient connection between the adhesive on the underside of the shingle, with the roof. This led to shingle tabs flipping over and pulling the shingles over the nail heads. The close-up photos show this in detail:

Close-up photographs showing typical shingle failures with the nails still in the roof (left) and one of the shingles that came off with two nail holes visible (right).
